J.D. KLINE WATER SUPPLY PLANT DISINFECTION INTERRUPTION – AFTER INCIDENT REPORT

September 19, 2024

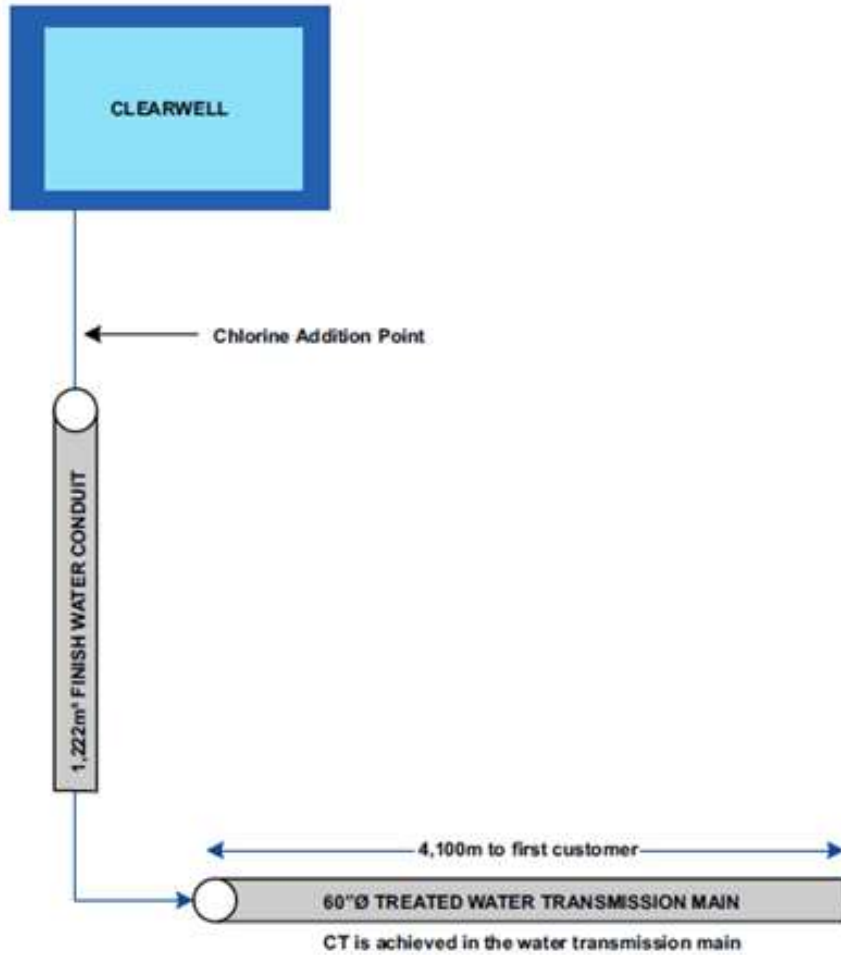
Figure 2-4: Simplified diagram showing primary disinfection process schematic and CT for the JDKWSP.

The JDKWSP was constructed in the 1970's to allow gravity flow through the treatment facility via the multimedia filters into the hydraulically connected clear wells and facility reservoir, and then consolidated into the treated water mixing chamber where chlorination occurs prior to leaving the plant through the finished water conduit into the transmission main (1500mm) to Halifax. There is no storage of chlorinated water onsite, and therefore chlorination at the outlet mixing chamber is always required to achieve primary disinfection. Primary disinfection is achieved in the finished water conduit at the treatment plant and in the transmission main between the facility and the first customer (Figure 2-4).

Baffling Factor = 1.0
Min. Cl = 0.7 mg/L
Min. Water Temperature = 0.5° C
Max. pH = 8.0
Total Volume = 8701 m³
Max. Flow = 220 ML/day
Min. Retention Time = 57 minutes

All treated water in storage at the JDKWSP is unchlorinated. The additional finished water chlorine application only occurs when all filtered water is consolidated into a single mixing chamber before leaving the plant through a finished water conduit. At this point in the process, it is not possible to interrupt flow from the finished water conduit, and chlorination at the outlet mixing chamber is required at all times to achieve primary disinfection and to meet regulatory requirements. Both chlorination and flow, therefore, cannot be interrupted without incurring a significant water quantity or quality event.

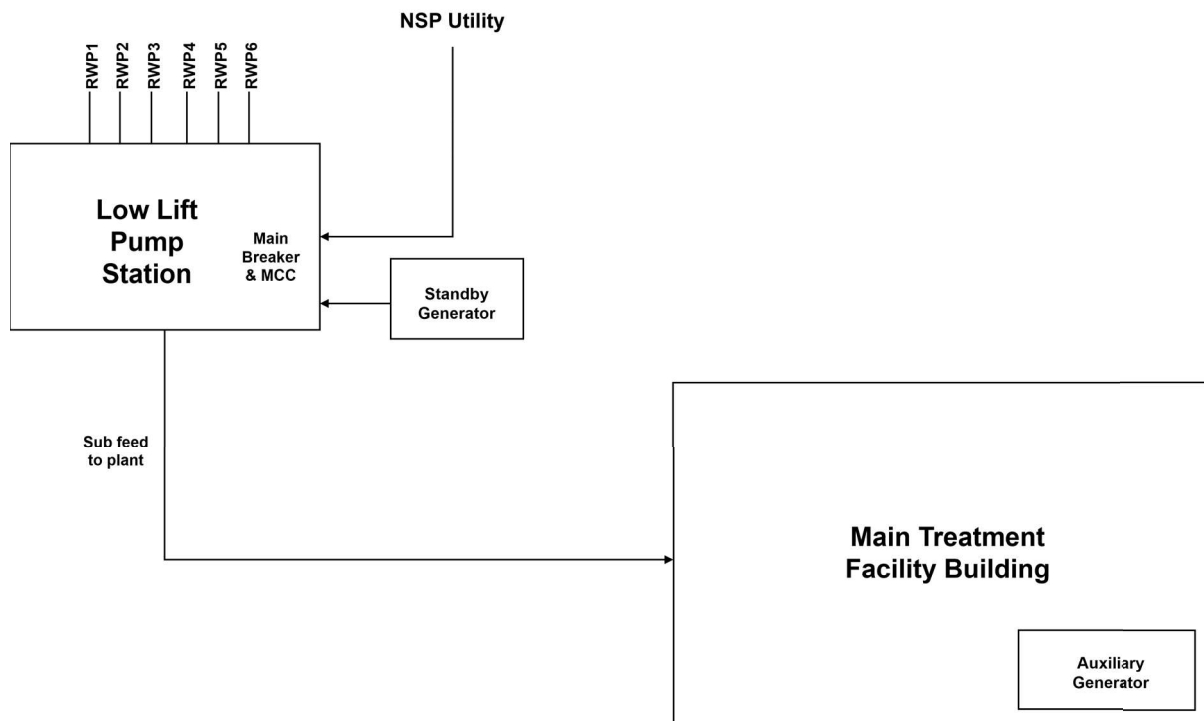
Figure 2-5: Simplified overview of power flow and relevant electrical components at the JDKWSP.

The external Nova Scotia Power feed enters the low lift pump station and power is subsequently routed from the low lift pump station to the main treatment facility through switchgear via an overhead distribution line where the voltage is stepped down feeding a motor control center (MCC) located at the main treatment facility. A diesel standby generator located at the low lift pump station provides standby power in the event of loss of utility power to the switchgear. The main treatment facility is equipped with a diesel standby generator (referred to as “auxiliary generator”) in the event there is an interruption of the power feed from the low lift switchgear. The auxiliary generator is designed to provide temporary power in the event of a power interruption as all plant power, including the main generator, is routed through the low lift pump station. Figure 2-5 provides a simplified schematic of the power flow to both buildings.

Based on the post-incident inspection, it has been determined that instead of the fuses and digital motor protection relay safety systems engaging, the main utility breaker tripped and isolated the power supply to both the low lift pump station and the main treatment facility building. When this occurred, it took both the low lift pump station and main treatment facility building offline because the power feed for both is located at the low lift pump station, and both loads are downstream of the breaker.

When the ground fault occurred on RWP1 it was significant enough that it tripped the main utility breaker before the other layers of protection could react. The sequence of trip alarms/signals between the digital motor protection relay, fuses and main utility breaker is complex and dated due to varying vintages of equipment technology. As a result, it can have an impact on switching speed and sensitivity, which may have had a role in why the main utility breaker detected the ground fault and tripped before the other layers of protection.
