Lake Major Watershed Newsletter

Summer 2022 *SPECIAL* Edition

Lake Major Dam Fishway

New Lake Major Dam and Fishway

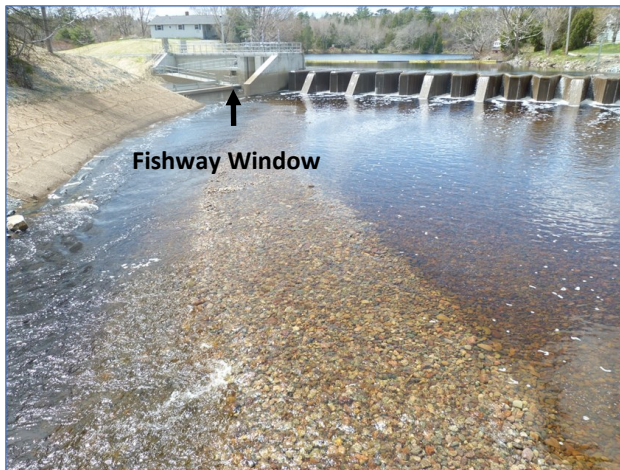
The figure on the right shows an overhead view of the fishway. At the bottom of the dam (see opposite page), the fishway entrance is located adjacent to the sluice gates. The fishway has a single turn pool and an extended exit pool at the top, leading into the lake. The final exit weir provided a good overhead view of fish leaving the fishway and was used to tally fish passage numbers.
