**RE: M11894 – J.D. Kline Water Supply Plant Disinfection Interruption
– January 21, 2025 After Incident Review**

Chapter 1	Introduction.....	3
1.1	Background	3
1.2	Objectives and Scope	3
1.3	Sources of Information	3
Chapter 2	J.D. Kline Water Supply Plant.....	4
2.1	Process Overview and Service Area	4
2.2	Minimum Treatment Requirements	7
	2.2.1 Achieving Primary Disinfection at the JDKWSP	7
2.3	Electrical Service Overview	9
Chapter 3	After Incident Investigation	10
3.1	Incident Description	10
3.2	Underlying Causes Leading to Boil Water Advisory	13
	3.2.1 Cause #1: Mechanical and Electrical Failures	13
	3.2.2 Cause #2: Fundamental Design Constraints	14
	3.2.3 Other Compounding Factors.....	15
Chapter 4	Recommended Corrective Measures and Progress Status	16

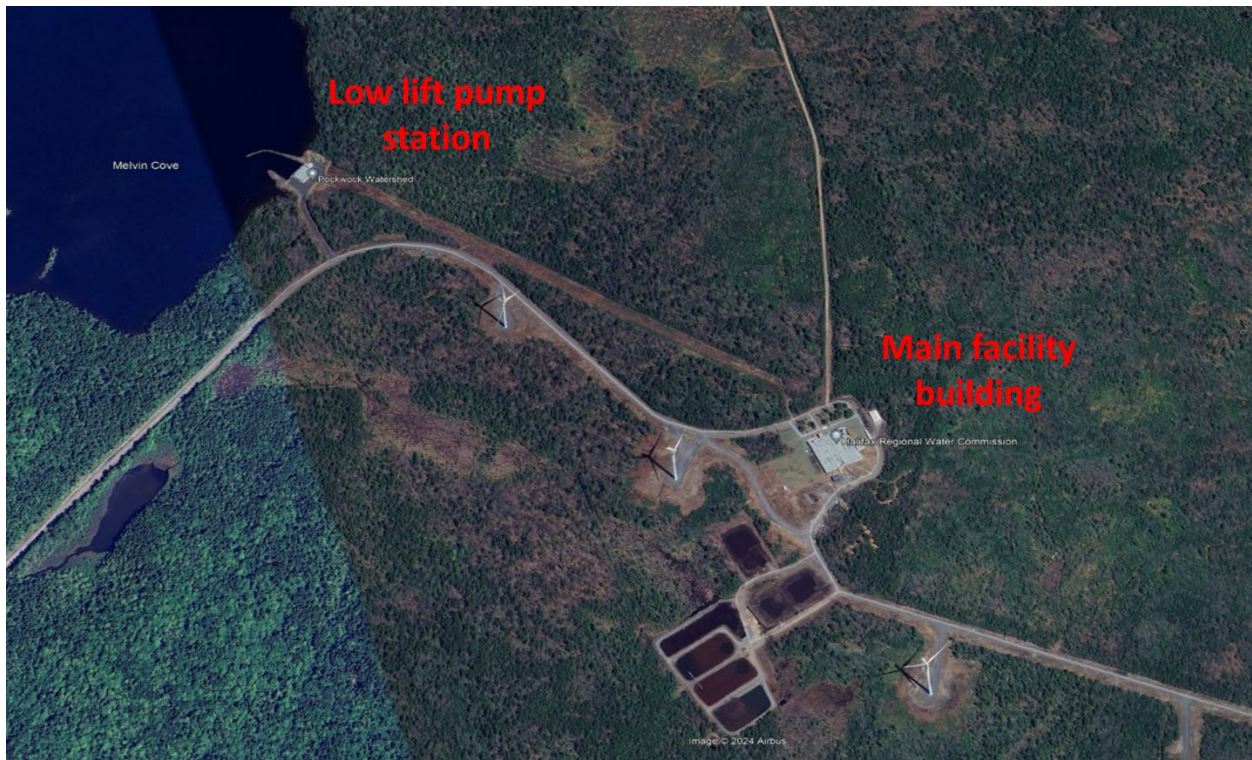
Figure 2-2: Aerial Photograph of the JDKWSP indicating the low lift pump station and the main treatment facility building.

The JDKWSP serves approximately 201,000 customers in the communities of Beaver Bank, Middle and Lower Sackville, Hammonds Plains, Bedford, Halifax, Timberlea, Spryfield, Portions of Fall River, Windsor Junction and Herring Cove (Figure 2-1). Commissioned in 1977, the plant produces an average daily flow of approximately 85 ML/D (22.5 MGD) with a design capacity of 220 ML/D (58 MGD) and is the largest water supply plant in Atlantic Canada. Based on the source water quality at the time of design, the facility was designed as a direct filtration plant with raw water sourced from Pockwock Lake. The JDKWSP has two main buildings – the low lift pump station, and the main treatment facility building (Figure 2-2).

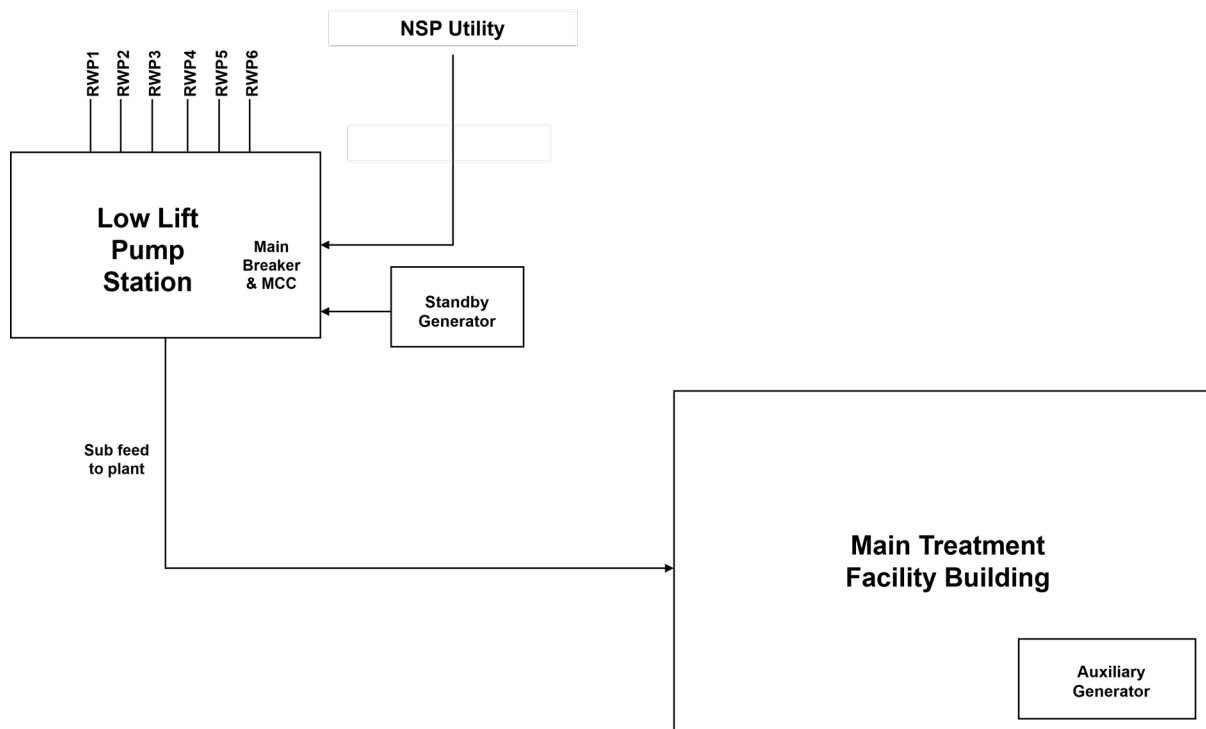
Figure 2-5: Simplified overview of power flow and relevant electrical components at the JDKWSP.

The JDKWSP receives electricity from Nova Scotia Power through high voltage overhead lines to a pad-mounted transformer and an eight-cell medium voltage distribution switchgear system. This switchgear system is composed of electrical disconnect switches, fuses or circuit breakers, and generator panels, that are designed to protect and isolate electrical equipment to the low lift pump station and the main power feed to the treatment facility.

The external Nova Scotia Power feed enters the low lift pump station and power is subsequently routed from the low lift pump station to the main treatment facility through switchgear via an overhead distribution line where the voltage is stepped down feeding a motor control center (MCC) located at the main treatment facility. A diesel standby generator located at the low lift pump station provides standby power in the event of loss of utility power to the switchgear. The main treatment facility is equipped with a diesel standby generator (referred to as “auxiliary generator”) in the event there is an interruption of the power feed from the low lift switchgear. The auxiliary generator is designed to provide temporary power in the event of a power interruption as all plant power, including the main generator, is routed through the low lift pump station. Figure 2-5 provides a simplified schematic of the power flow to both buildings.
